CZM Coastal Resilience Grant Program

Evaluation of Coastal Processes and Storm Impacts to Support Resilient Planning and Mitigation Strategies for the Vineyard Haven Harbor Shoreline

Prepared for:
Town of Tisbury, MA

Prepared by:
Applied Coastal
Research and Engineering, Inc.

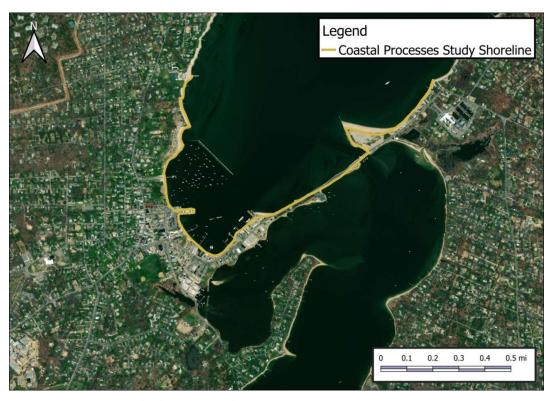
Figure I.1 Map illustrating the Vineyard Haven Harbor area where the site-specific coastal processes analysis was completed.

The shoreline evaluated in this study extends from the end of the breakwater at the western side of the Harbor, along the interior of the Harbor, and out to the Eastville jetty (Figure I.1). The overall evaluation focused on identifying "weak points" in existing infrastructure, within the project area, to prevent flooding of downtown along storm tide pathways. The three prioritized regions include (Figure I.2):

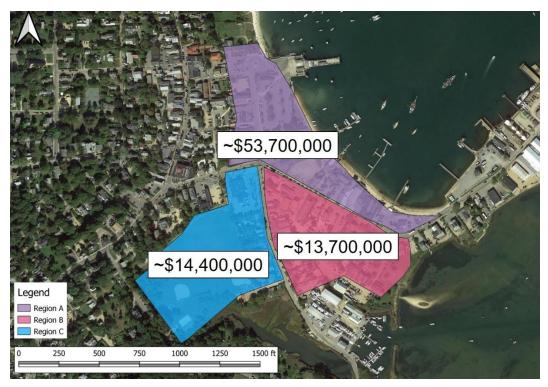
Figure I.2 Map illustrating the Vineyard Haven Harbor area where the site-specific coastal processes analysis was completed.

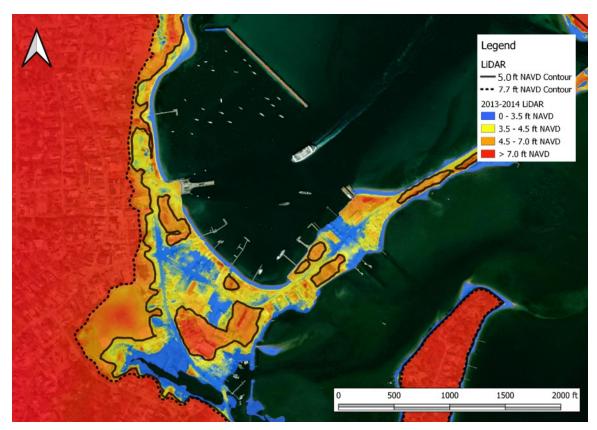
Figure I.3 Color-contour elevation map of Vineyard Haven Harbor shoreline indicating areas below the 100-year flood elevation of 7.7 feet NAVD88 (white line), as well as the severe storm surge levels experienced during nor'easters (5.0 feet NAVD88) in gray.

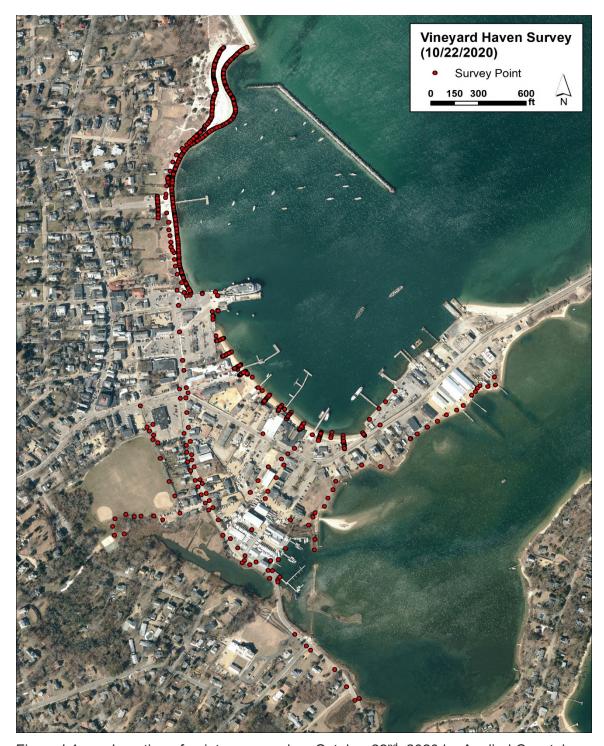
Figure I.4 Location of points surveyed on October 22nd, 2020 by Applied Coastal.

The locations of the survey points for the Applied Coastal assessment are shown in Figure I.4, and the additional surveys in Figure I.5. These point data helped to fill in gaps where the 2018 LiDAR had missing data, or were not sufficiently refined to determine the elevation of specific structures or features. The augmented data set provided necessary detail specific to roadway elevations and the shoreline to ensure flood mitigation designs accounted for *in situ* conditions, which is especially critical for Vineyard Haven Harbor, where small differences in topography can have a significant influence upon storm tide pathways.

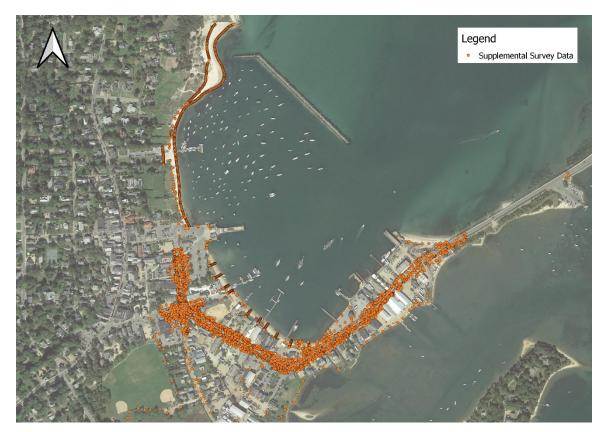
Figure I.5 Location of all additional survey points collected to compliment the 2018 LiDAR dataset.

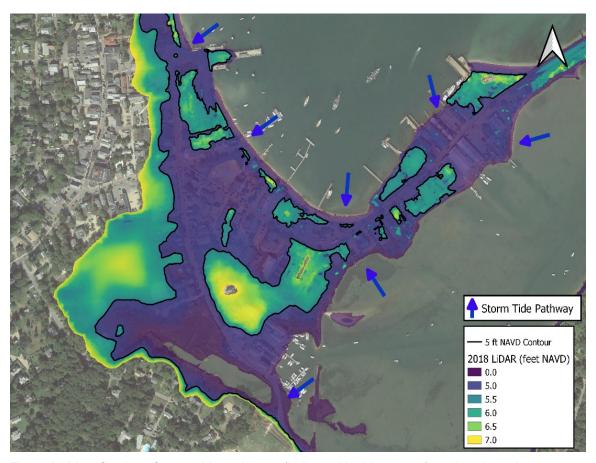
Figure I.6 Identification of storm tide pathways (indicated by blue arrow), as locations downtown at or below 5.0 feet NAVD88 that fringe the harbor or Lagoon Pond, and would allow storm waters to flood downtown areas.

Based on the analysis of elevation data from both the LiDAR and surveys, storm tide pathways were identified on aerial maps (Figure I.6). Regionally, the term storm tide pathways is a concept developed by Mark Borelli and Steve Mague (Borrelli et al. 2016), and are defined as the low-lying areas that channelize coastal flood waters during extreme high tide episodes. The identification of these pathways can allow managers and planners to determine what portions of the developed shoreline "enable" coastal flooding during a particular storm event. Mapping and modeling of these storm tide pathways can help coastal communities prepare and plan for inevitable hazards from storms and future sea level rise.

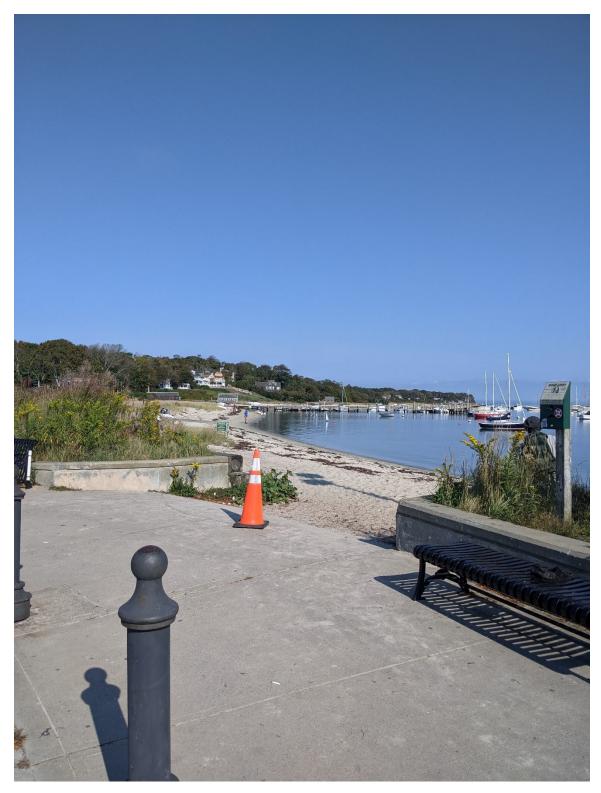
Figure I.7 October 2020 photograph looking northward along the harbor shoreline, with the storm tide pathway through the sidewalk in the center of the image.

Storm tide pathways were identified in all three regions of the downtown Vineyard Haven as part of this assessment. Along the harbor shoreline, pathways were primarily located at the end of roads or driveways, as well as at beach access points. The simplest method of mitigating these pathways along the harbor shoreline, would be the construction of a dune or other upland feature, to elevate the back of the beach. Another pathway exists to the north of the Steamship Authority terminal (Figure I.7).

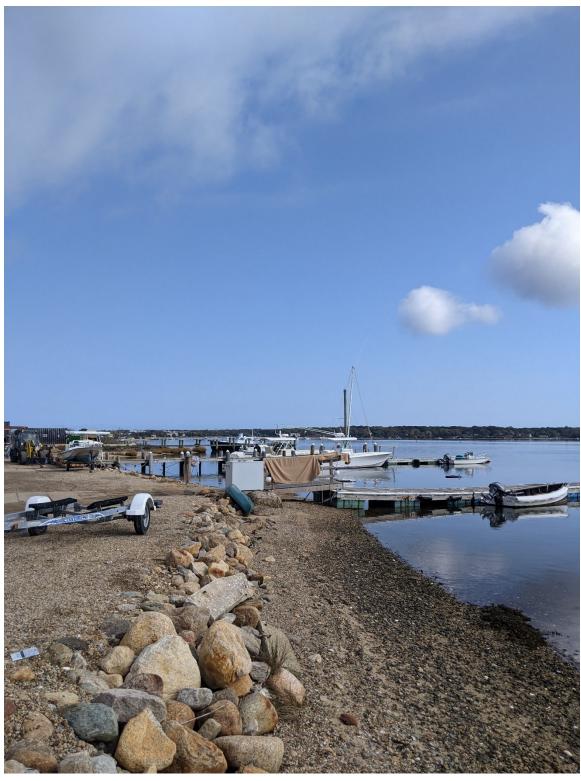
Figure I.8 October 2020 photograph looking northeast along the Lagoon Pond shoreline. Several pathways exist along this section of shoreline, and provide a path for flood waters to reach Beach Road.

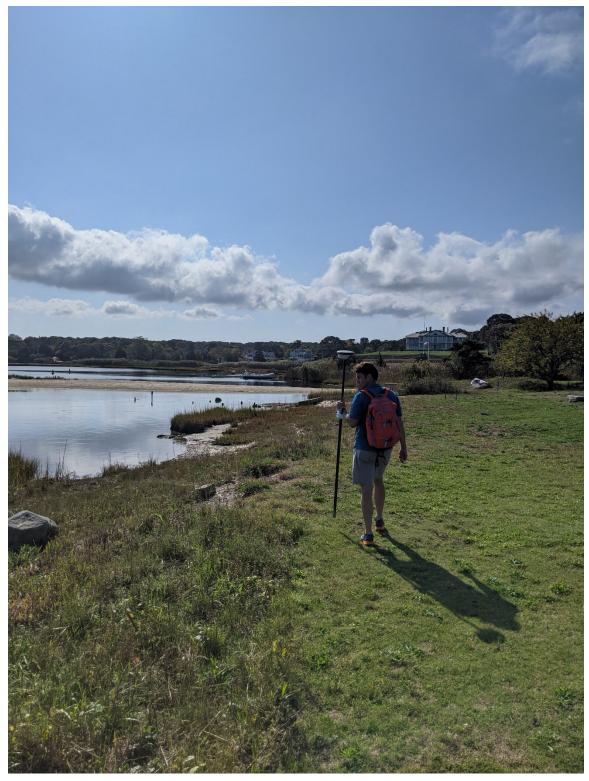
Figure I.9 October 2020 photograph looking southwest along the Lagoon Pond shoreline. Several pathways to the east of the Tisbury Market Place allow flooding to reach Beach Road.

The Beach Road section includes one pathway across a gravel parking lot located within the Packer Facility. However, it is anticipated that planned projects at this location will elevate the lot to approximately 6.0 feet NAVD. Several pathways exist on the Lagoon Pond side of Beach Road. The section of shoreline furthest to the east is protected by a revetment (Figure I.8). However, the structure is at approximately 3.5-4.0 feet NAVD, and therefore permits flooding during moderate to severe storms. The shoreline to the southwest of that location includes a pathway along some sections of developing marsh with grass behind it (Figure I.9). Several pathways exist along here that connect to Beach Road through gravel parking lots.

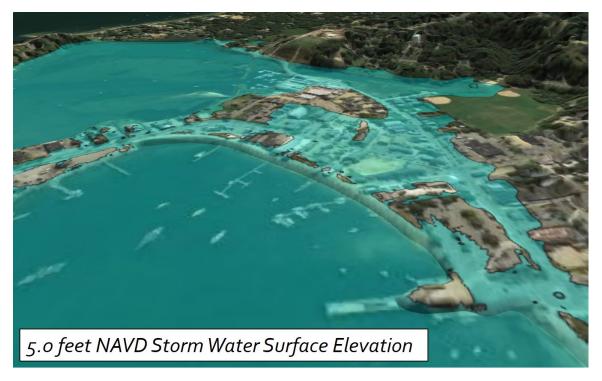
Figure I.10 Flood model of downtown simulating a storm of 5.0 feet NAVD. The elevation model highlights the impact of storm tide pathways and the propagation of flood waters downtown.

The overall pathways were also identified with a 3D terrain map, that included all collected elevation data. A simulation flood of 5.0 feet NAVD was included, to help visualize the extents of the flooding downtown.

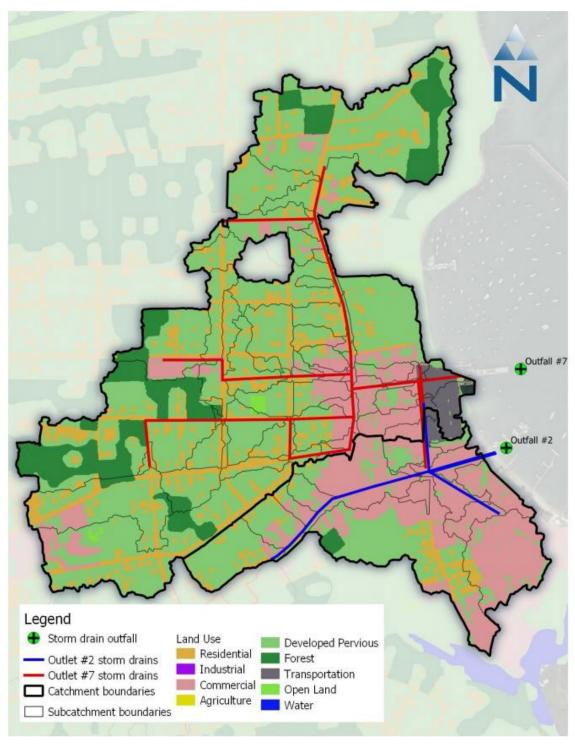
Figure I.11 Sub-catchment delineation and major land use in the drainage areas to outfall #2 and #7 (Paradigm Environmental et al. 2020).

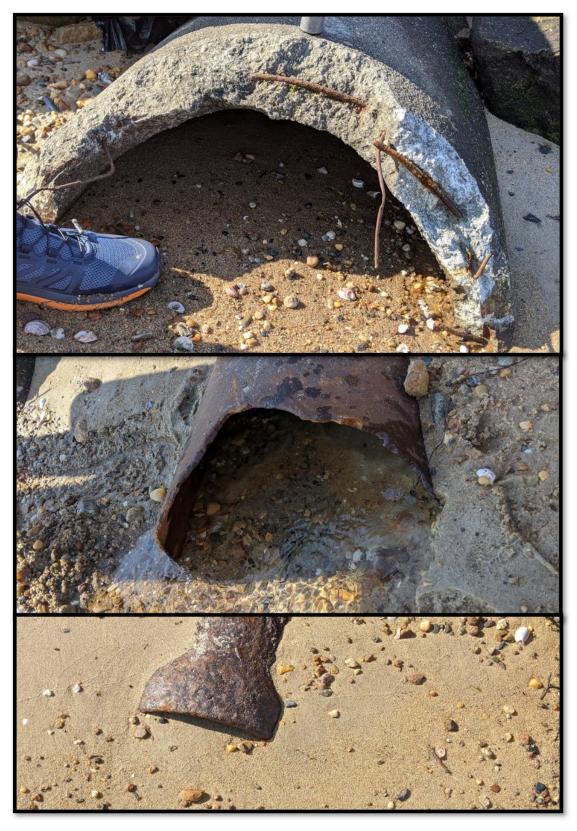
Figure I.12 Drainage pipes at the Outfall #2 location (Figure I.11).

The collaborative study brought together regulators, technical experts, and community leaders to identify opportunities for innovative stormwater management techniques. While it did include in-depth analyses of storm volume and total nitrogen (TN) load reduction opportunities, it did not take into account the details of the existing stormwater routing network. A major issue in the existing stormwater drainage network is the sedimentation and clogging of one of the major harbor outfalls (i.e., Outfall #2; Figure I.11). The outfall that crosses the beach at Beach Road Extension tends to fill with sand during storm conditions, preventing the outfall from being effective (Figure I.12).

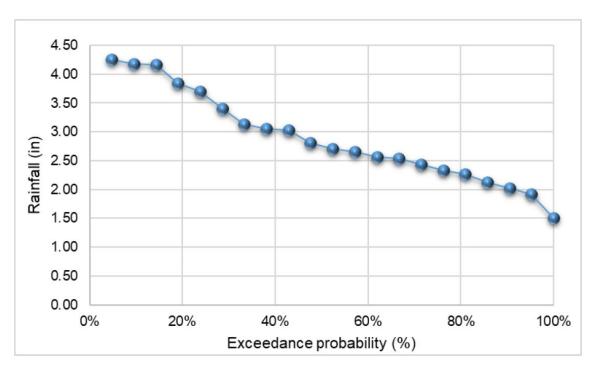
Figure I.13 Exceedance probability for annual maximum daily rainfall amounts for 21-year period (1998-2018) for Tisbury, MA (Paradigm Environmental et al. 2020).

As both storm surge and rainfall within the harbor watershed generate flooding in downtown areas, it is critical to determine the relationship between the two phenomena. To assess the watershed influence, the EPA report used a 20-year (1998 to 2018) hourly precipitation timeseries and daily air temperature data collected at the NCDC Global Hourly Surface Data gauge located at Martha's Vineyard Airport (USAF-ID 725066). They developed an exceedance probability curve (Figure I.13), which indicates a storm with a 100% annual exceedance probability to generate 1.5 inches of daily rainfall. A 2-3% exceedance probability (30–50-year storm) is approximately 4.2 inches of daily rainfall.

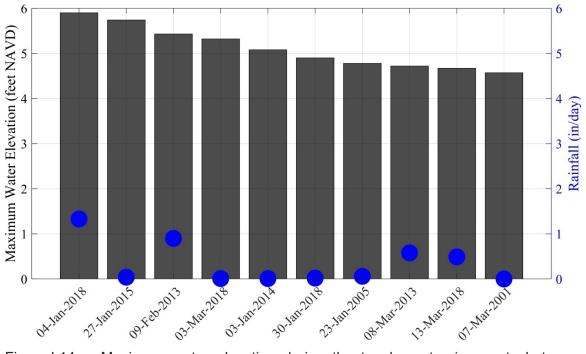
Figure I.14 Maximum water elevation during the ten largest rain events between January 1, 1998 and December 31, 2018.

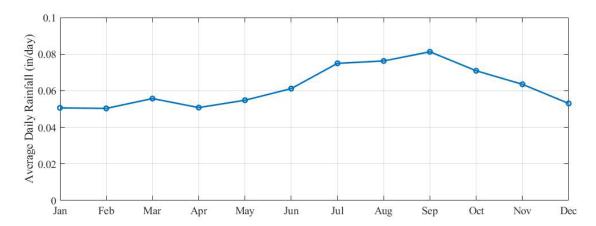
Figure I.15 Average daily rainfall for each month of the 20-year period. Only days in which measured rainfall was greater than 0.01 inches were included in the average.

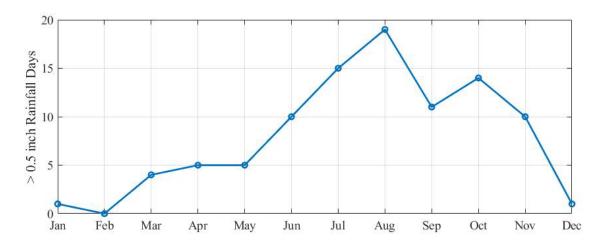
Figure I.16 Number of days in which rainfall greater than 0.5 inches were recorded at Martha's Vineyard Airport between 1998 and 2018.

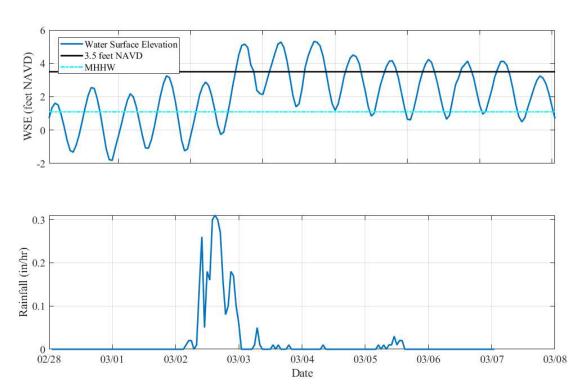
Figure I.17 Plot of eight days of water surface elevation (top) and the corresponding rainfall (bottom). The location of the 3.5-foot NAVD flood elevation contour provided in Figure I.18) is included for reference, in addition to mean higher high water (MHHW).

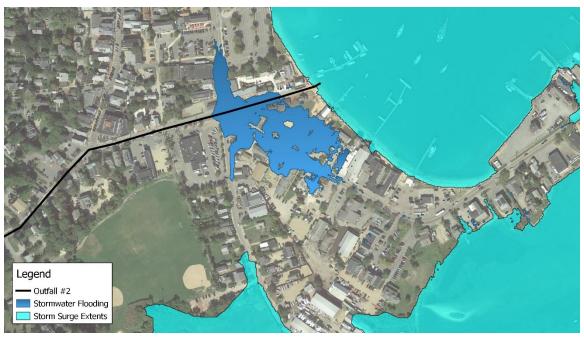
Figure I.18 Location of coastal storm surge and stormwater flooding during a 3.5-foot NAVD flood elevation. Stormwater primarily will flood around the five corners intersection of downtown.

Anecdotally, flooding of the downtown area from rainfall occurs frequently for a broad range of events, for both moderate and severe rainfall. However, improvements to the drainage system, accompanied by proper maintenance of stormwater outfalls, will eliminate most of the stormwater flooding, when there is no corresponding significant storm surge. The extent of flooding at five corners flooding is shown in Figure I.18.

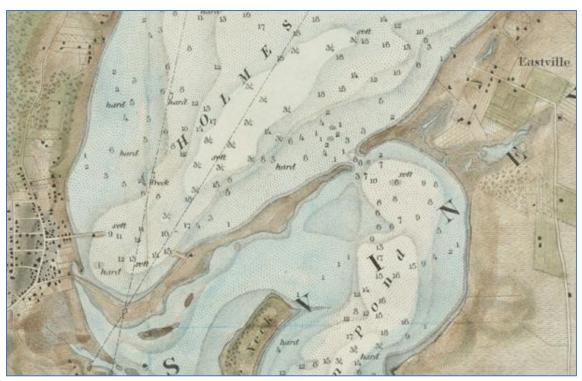
Figure I.19 Section of the 1847 U.S. Coast Survey navigation chart for Holmes Hole (Vineyard Haven Harbor) illustrating the natural deep channel along the length of the Harbor, as well as early pier development in the vicinity of the Packer Facility.

The naturally deep thoroughfare down the major length of the protected Harbor (Figure I.19), running northeast to southwest, provided the basis for a commercial port in Vineyard Haven Harbor, where in the late 1800s there were lofts to repair sails; a shipbuilding company to repair hulls and rigging; and a marine hospital. Vineyard Haven (called Holmes Hole until 1871) was home to the Holmes Hole Marine Railway starting in the 1840s that constructed numerous schooners along the barrier beach system separating the Harbor from Lagoon Pond (see 1890 chart in Figure I.20). Subsequent to the marine railway development, thousands of feet of Harbor shoreline were commandeered as a construction site for barges and high-speed rearmament/personnel boats for World War II. This shoreline remains in commercial use as the Tisbury Marine Terminal.

As depicted in Figure I.19 and Figure I.24, very little bathymetric change occurred between the mid-1800s and 1948 along the area immediately north of the barrier beach system, as the shallow shoal system adjacent to the shoreline continued to persist. As shown in Figure I.19, the initial pier construction from the barrier beach system was located at the closest proximity to the naturally deep Harbor channel. Overall, it appears that prior to WWII, the water depths adjacent to the barrier beach were generally natural. However,

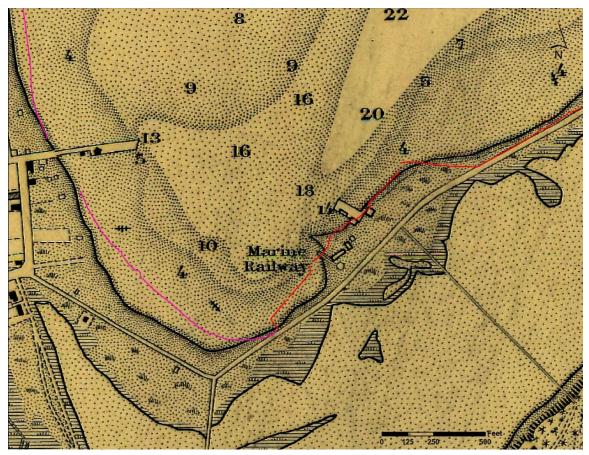
Figure I.20 Section of the 1890 U.S. Coast Survey navigation chart for Vineyard Haven Harbor illustrating the marine railway development in the vicinity of the Packer Facility, as well as creation of a roadway along the length of the barrier beach system and causeways across the marsh system.

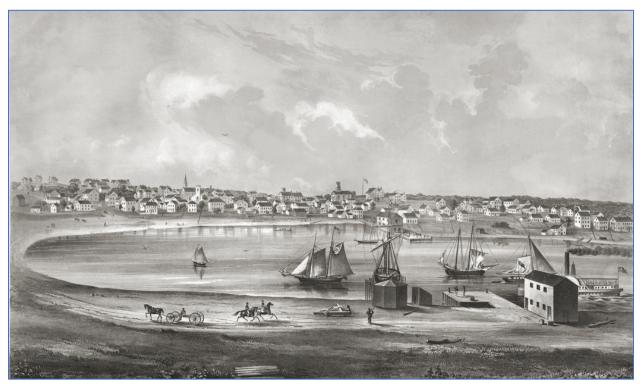
Figure I.21 Artist's rendering of Holmes Hole (Vineyard Haven Harbor) in 1856, where the pier facility along the barrier beach separating the Harbor from Lagoon Pond is depicted in the foreground. Note, no roadway existed along the barrier beach at this time and goods were transferred to town along the sandy beach.

The series of oblique views of the Harbor from 1856, 1880, and 1890 are shown in Figure I.21, Figure I.22, Figure I.23, respectively. These sketches illustrate the gradual development of the port facilities along the low-lying section of the barrier beach system. As illustrated in Figure I.21, it is clear that after construction of the pier facility that was developed to reach the naturally deep water in Vineyard Haven Harbor, access to the pier was along the inter-tidal beach and no formal road was developed along the barrier beach. Subsequent time periods indicate that the development of causeways across Lagoon Pond and roadway construction led to man-made stabilization of the barrier beach system. These long-term stabilization efforts prevented the low-lying barrier beach from naturally migrating landward as a result of gradual sea-level rise over the past 100+ years or to periodic storm events.

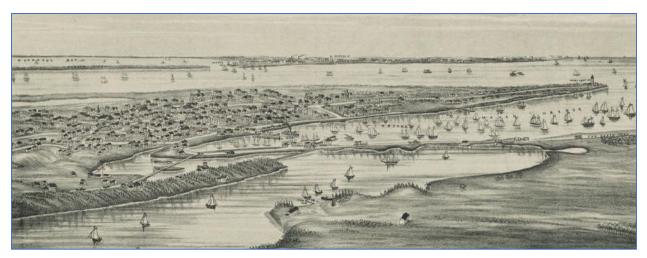
Figure I.22 Birdseye view of Vineyard Haven Harbor in 1880 (from the south) illustrating the causeways constructed from the mainland to the barrier beach, as well as the roadway along the beach.

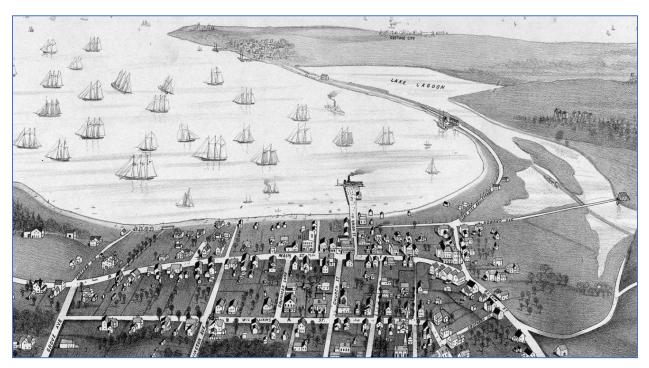
Figure I.23 Birdseye view of Vineyard Haven Harbor in 1890 (from the west) illustrating the causeways constructed from the mainland to the barrier beach, as well as the roadway and pier facility along the beach.

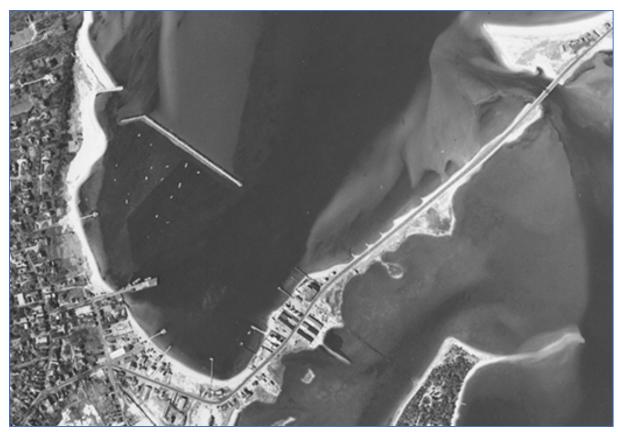
Figure I.24 Post-World War II aerial photograph from 1948 illustrating the shipbuilding facilities along the barrier beach system, the series of groins to the east of the present-day Packer Facility, and the breakwater protecting the main Harbor basin. Based on the photograph, it appears that the water immediately adjacent to the upland had not been dredged.

Figure I.25 provides photographic evidence of the historical low-lying nature of the barrier beach in 1900 relative to the port facilities constructed along the barrier beach. In addition, Figure I.24 visually indicates the narrow beach system to the east of the port area, where a series of groins were established to mitigate erosion. Over the subsequent decades, State Road and adjacent upland development has been stabilized to ensure access between Vineyard Haven and Eastville. These stabilization efforts have worked to prevent landward migration of the barrier beach system; however, they also have prevented natural erosion processes from occurring. Therefore, the sediment supply along the beach system has decreased over time and sediment availability along the shoreline between the Packer Facility (i.e. the Tisbury Marine Terminal) and the State Road bridge to Eastville is minimal.

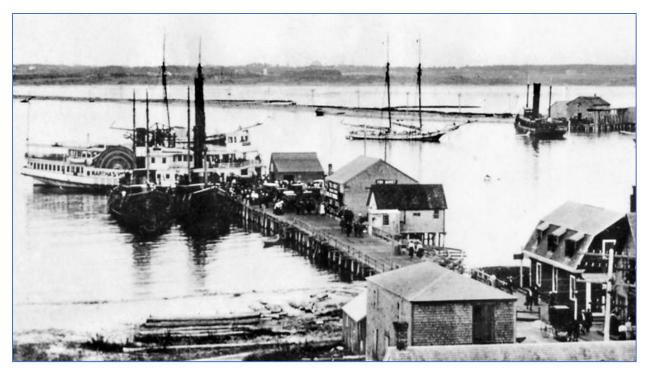
Figure I.25 Photograph from 1900 showing the Steamship Pier in the foreground. The low-lying barrier beach system and pier facility along the barrier beach can be seen in the upper part of the photograph.

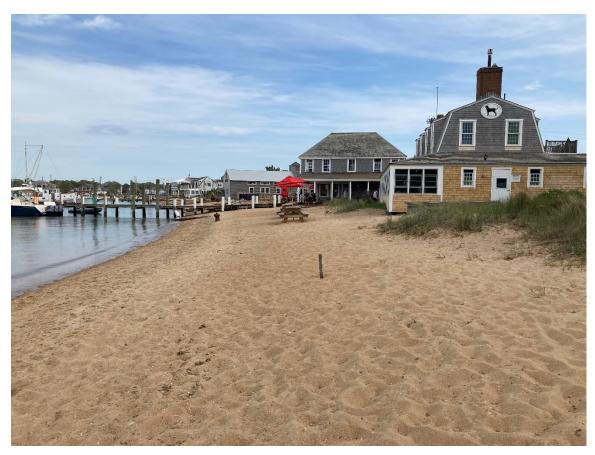
Figure A.1 Example of the variability in shoreline elevation, looking southeast from the western end of the harbor shoreline towards the Black Dog Tavern.

In general, larger volume high dunes provide more lasting protection; however, the appropriate scale of dune shore protection is dictated by the local storm surge elevation, as well as the storm wave climate. Due to the natural and man-made shore protection features of Vineyard Haven Harbor, the storm wave climate is relatively modest. Further, the project purpose is to address more frequent coastal flooding events caused by nor'easters; therefore, the dune elevation necessary to mitigate storm surge flooding also is modest. While the existing shoreline has variable levels of shore protection from beach and dune features, the major storm tide pathways are primarily at beach access points at the end of each road. Figure A.1 shows the variability in elevations along the shoreline, with the beach crossing near the Steamship Authority Parking Lot, at approximately 3.8 feet NAVD in elevation.

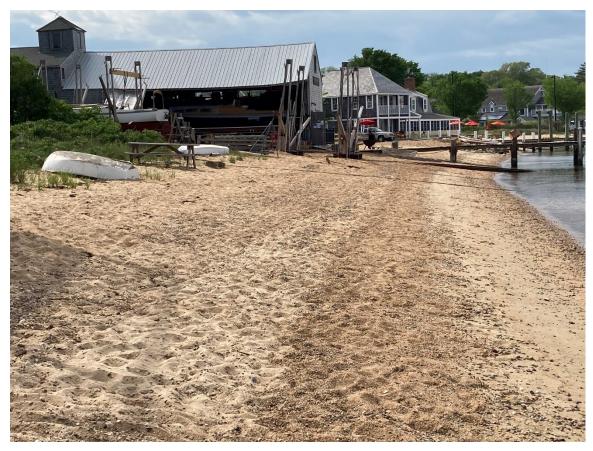
Figure A.2 Example of the variability in shoreline elevation, looking southeast from the western end of the harbor shoreline towards the Black Dog Tavern.

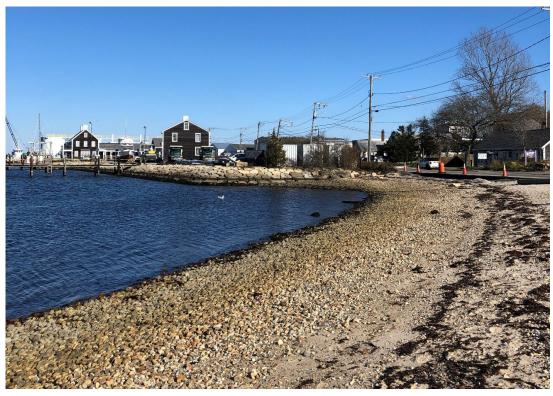
Figure A.3 Image looking to the east along the harbor shoreline from the section of beach fronting the Shell Station (November 7th, 2019).

eroded (Figure A.3 and Figure A.4) primarily due to impacts from the adjacent armored shoreline (i.e., "end effects" associated with the structure). Long-term shoreline change analysis in the FY20 report concluded that erosion is prominent at this end of the shoreline (Figure A.5). In addition, the report provided wave modeling results within the harbor during a storm (Figure A.6) and found that this section will require additional protection as compared to the remaining sections of shoreline. Therefore, it is anticipated that the MA DOT nourishment project will include coarse material (i.e., gravel or cobble) to mitigate the "hot spot" erosion at this location. It is important to recognize that the purpose of this project, is first and foremost to provide protection for upland infrastructure (e.g., Beach Road). The crest of the nourishment is designed to an elevation of 4.5 feet NAVD (Figure A.7 and Figure A.8), which does not meet the 30-to-50-year target flood protection elevation of 5.0 feet NAVD. Therefore, supplemental material will be required to raise the profile, although the necessary volume will be inconsequential relative to the dune construction requirements for the remainder of the shoreline.

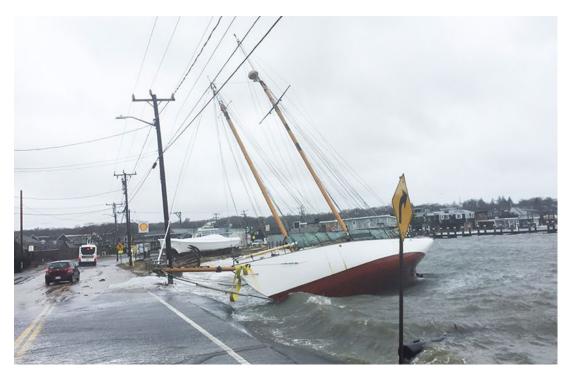
Figure A.4 Image looking to the west from the eastern end of the harbor shoreline along Beach Road, on March 3rd, 2018. The high storm surge flooded Beach Road, resulting in difficulties with navigation.

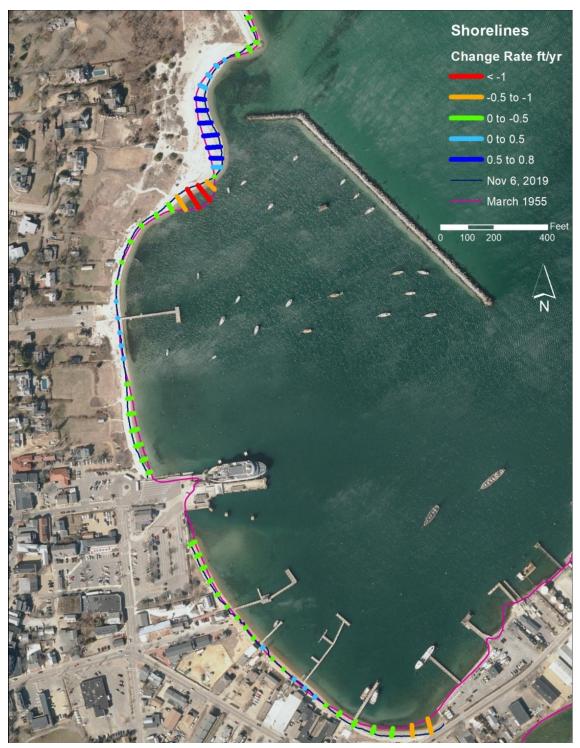
Figure A.5 Results of shoreline change analysis using the March 1955 and November 2019 RTK-GPS shorelines. Color bars indicate a range of shoreline change computed along Vineyard Haven shoreline. Negative rates indicate erosion, and are represented by the colors yellow, orange, and red. Areas of accreting shoreline are indicated by green and light and dark blue.

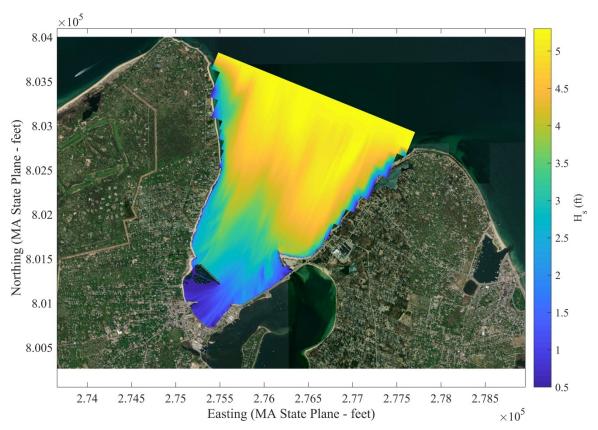
Figure A.6 Map of significant wave height in feet within the harbor. Wave heights prescribed at the seaward limit of the harbor in Vineyard Sound were on average 5.3 feet, based on outputs from the large-scale regional grid.

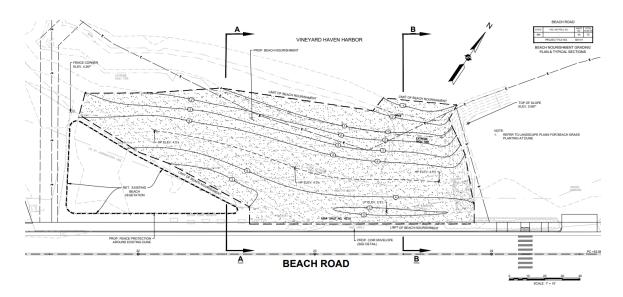
Figure A.7 Footprint of Massachusetts DOT Beach Road Project nourishment. The location of transects A-A and B-B (Figure A.8) are identified in the map.

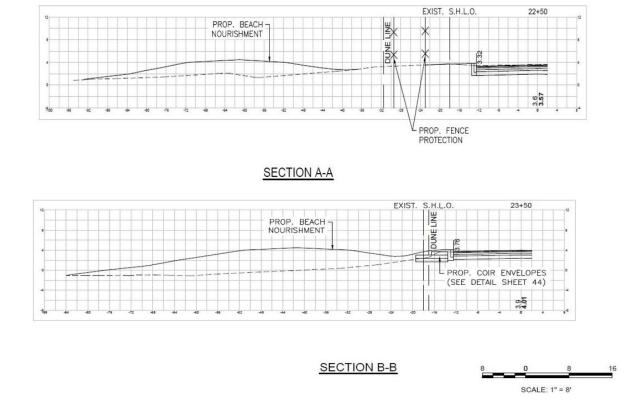
Figure A.8 Cross sectional view of the profile elevations along transects A-A and B-B.

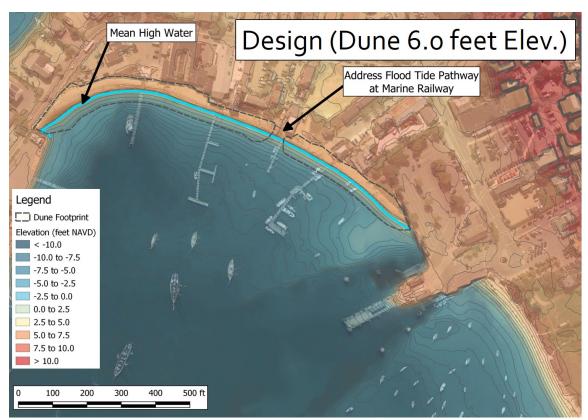
Figure A.9 Design contours based on digital elevation model. The dune footprint is included as a dashed line along with the existing mean high water (MHW) position for reference. The width of the dune fluctuates along the 1,280-foot stretch of shoreline between the Steamship Authority and the Packer Facility.

The primary purpose of this dune design, would be to elevate the existing shoreline to meet the target elevation of 5.0 feet NAVD. The length of the dune would extend along the 1,280-foot stretch of shoreline between the Steamship Authority and the Packer Facility (Figure A.9). The dune footprint was worked into the existing contours from 2018 LiDAR, supplemented by the Applied Coastal survey. Due to the extreme variability in existing grade and shoreline features, the design dune volume will vary significantly along the shoreline. Therefore, both permitting and design drawings will require numerous cross-sections to provide necessary detail for evaluating potential environmental impacts and planning construction.

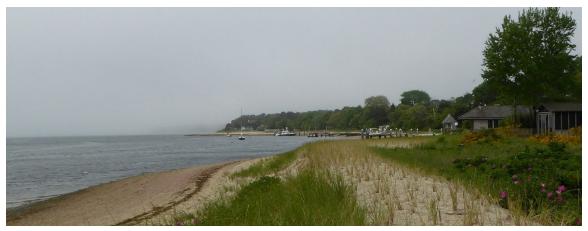
Figure A.10 Example of a low-elevation dune constructed for storm and flood protection in Cotuit, MA.

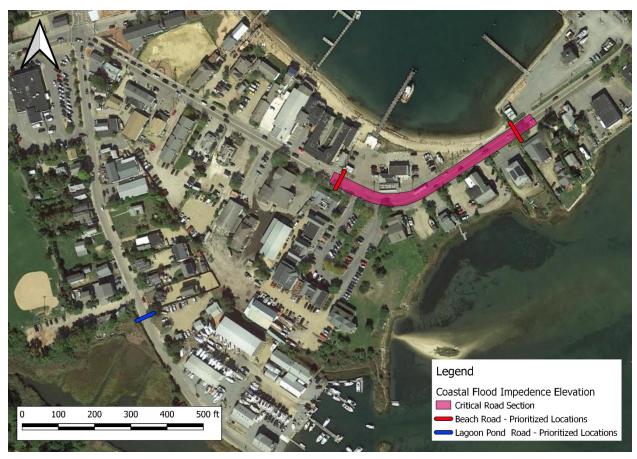
Figure B.1 Location of critical Beach Road section and the prioritized locations for elevating to 5.0 feet NAVD.

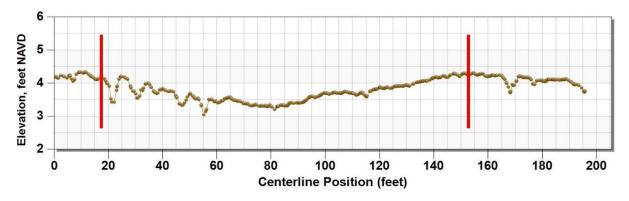
Figure B.2 Cross-section of Beach Road centerline elevations from a 2018 LiDAR dataset along the critical section identified in Figure 1. Also identified are the prioritized locations for reaching a road elevation of 5.0 feet NAVD.

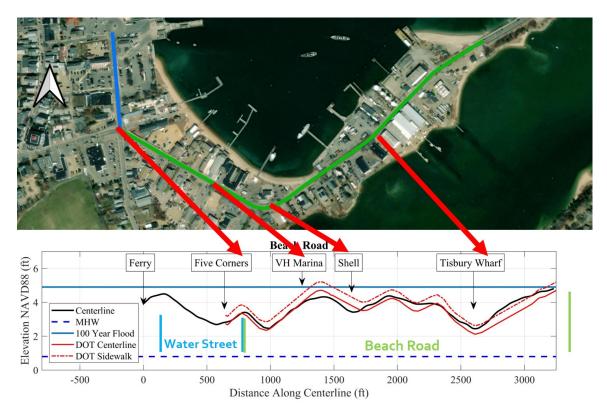
Figure B.3 Elevation profile of Lagoon Pond Road and Water Street. The red arrows identify important landmarks along the road.

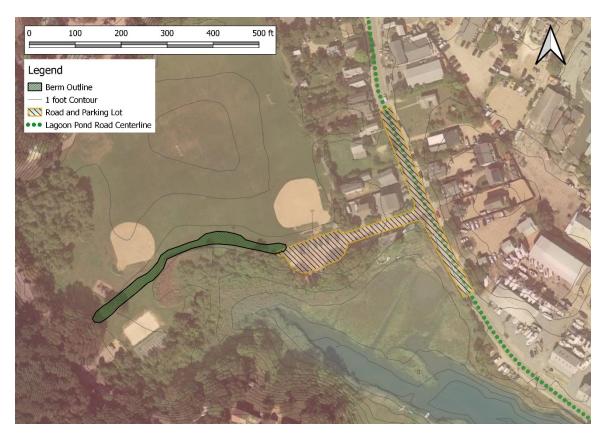
Figure C.1 Aerial map with location of proposed designs.

Following the October 2020 survey, an alternative approach to elevating land along Veterans Memorial Park became the preferred alternative over the culvert modification options, as elevating infrastructure would provide a method that could be readily modified as sea levels continue to rise. These structural modification options include the elevating of Lagoon Pond Road, the park parking lot, and the section of park at the southern end. The conceptual design would link the increased elevations within the park and along Lagoon Pond Road to the higher elevations to the west of downtown, as well as the high elevations to the east across the Lagoon Pond Road from Veterans Memorial Park. The relative locations of the designs are included in Figure C.1.

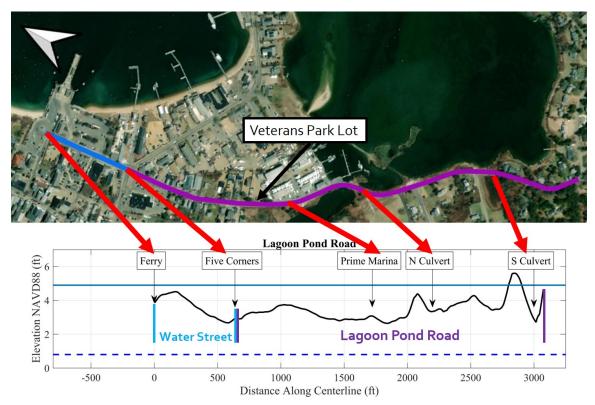
Figure C.2 Elevation profile of Lagoon Pond Road and Water Street. The red arrows identify important landmarks along the road.

The conceptual design includes the elevating of Lagoon Pond Road, beginning at the eastern end of the Prime Marina Shipyard at 100 Lagoon Pond Road (Figure C.2). The road can be modified further south, however, it only needs to reach the target design elevation of 5.0 feet in one location to meet the goals of the project. Due to the water dependent activities of the marina, it is recommended that buildings are elevated, rather than modifications be made to the shoreline itself. The southernmost building at the shipyard was elevated recently to bring the building above the FEMA 100-year flood level.

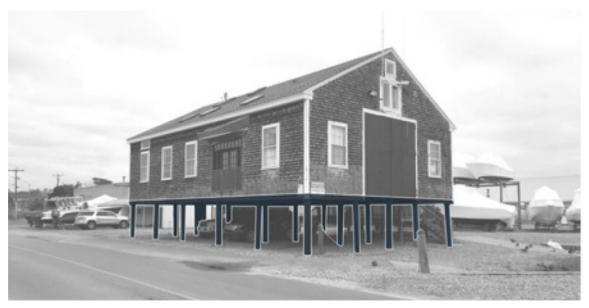
Figure C.3 Prime Marina structure at 100 Lagoon Pond Road. Some properties have begun to elevate service building in the waterfront (EPA 2020).

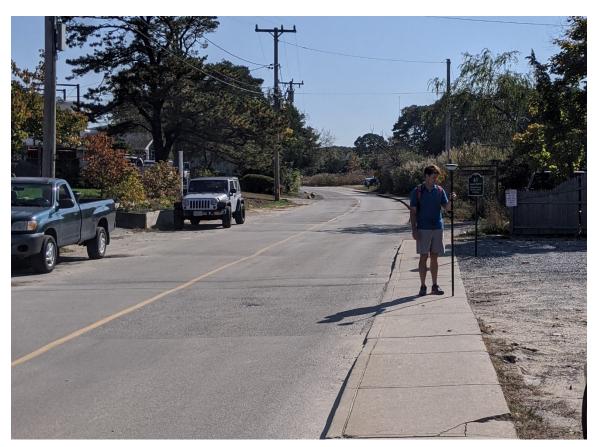
Figure C.4 October 2020 photograph looking southeast along the proposed section of Lagoon Pond Road to be elevated.

The road modifications should, at minimum, be made to the Veterans Memorial Parking Lot, to achieve the target elevation. The critical section of road is included in Veterans Memorial Parking Lot, to achieve the target elevation. The critical section of road is included in Figure C.4, looking southeast. An important consideration to be made is the modifications that will be made to abutting property owner driveways. However, with most of the homes along this section of Lagoon Pond Road have first floor elevations that are already above the road elevation, and driveway elevations should transition into the road well. The road modifications will tie into an elevated Veterans Memorial Parking Lot (Figure C.5). It is recommended that both the road and parking lot meet the 5.0 feet NAVD target, with the consideration of further elevating in the final design. Preliminary Lagoon Pond Road and parking lot grading are included in Figure C.6.

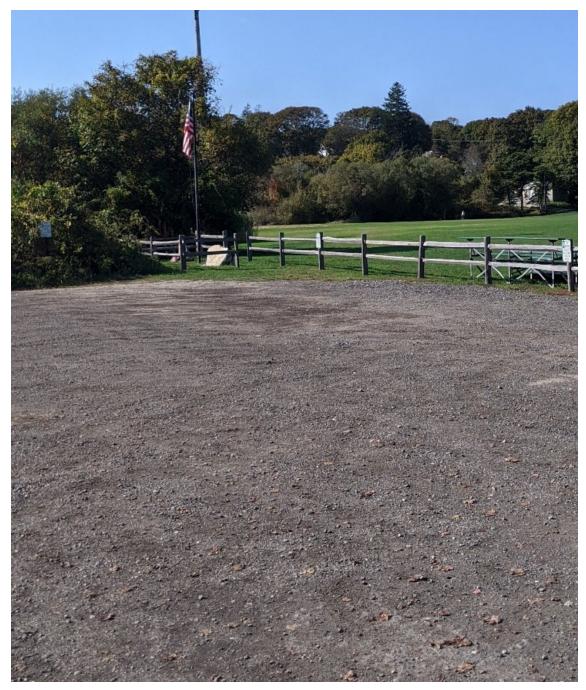
Figure C.5 October 2020 photograph looking southeast along the proposed section of Lagoon Pond Road to be elevated.

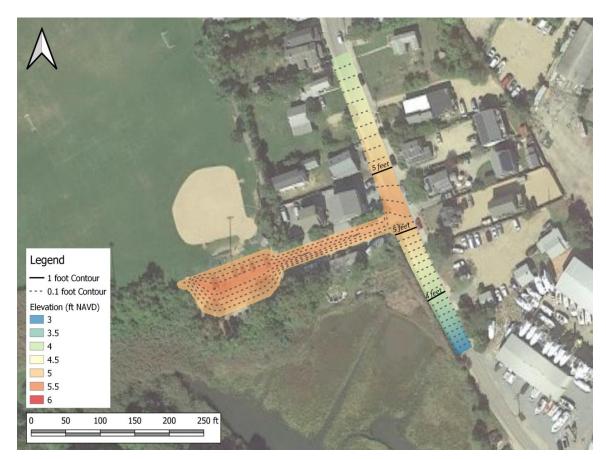
Figure C.6 Color contour elevations of the Lagoon Pond Road design.

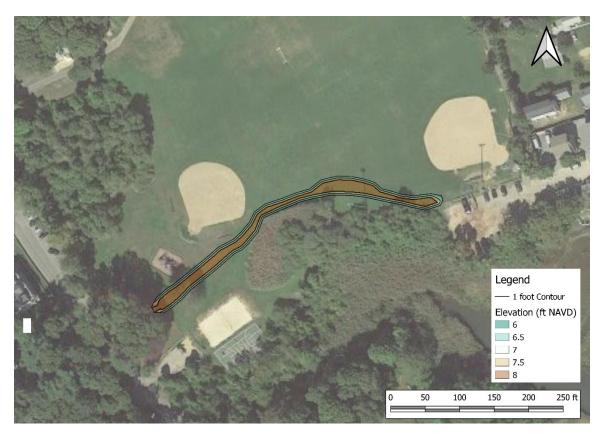
Figure C.7 Color contour elevations of the berm design for Veterans Memorial Park.

From the parking lot, a section of the park will be raised to approximately 7 to 8 feet NAVD, with a variable width of 20 to 25 feet. The change in topography to the existing contours are included in Figure C.7. This grass berm design would connect to the elevated parking lot and road to the higher elevations west of downtown. The design can feature seating areas for spectators to view events at the park and sporting fields. With only 3 to 4 feet of elevation modifications, any changes will be minimal.

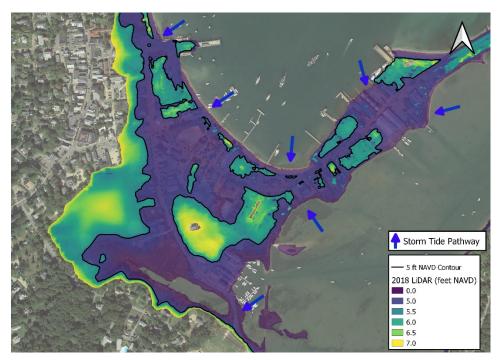
Figure 1 Location of primary storm tide pathways for the 5.0-foot NAVD design elevation. The 5.0-foot NAVD contour is outlined in black, with the primary storm tide pathways identified with a blue arrow.

Using this design elevation, in addition to the analysis of existing topography, several designs were developed and analyzed to try to prevent and minimize storm flooding along particular pathways indicated in Figure 1. These designs are relatively low impact, manageable projects for the Town to undertake to provide flood protection. The predominant proposed designs are as follows:

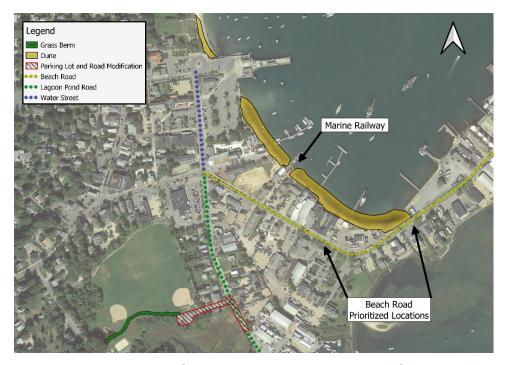
Figure 2 Locations of alternative designs proposed for downtown Vineyard Haven. As Beach Road is a state road, modifications ultimately depend on working with Massachusetts DOT. It is also important to note that alternative design options are under consideration at the location of the marine railway to maintain flood mitigation, but not impede on the operation of the structure.

To best visualize how these alternatives would look downtown, several maps were developed to see both the location of the designs (Figure 2), and the flood mitigation impacts. It is important to note that smaller modifications can contribute to flood protection efforts, and that these modifications can be increased moving forward.

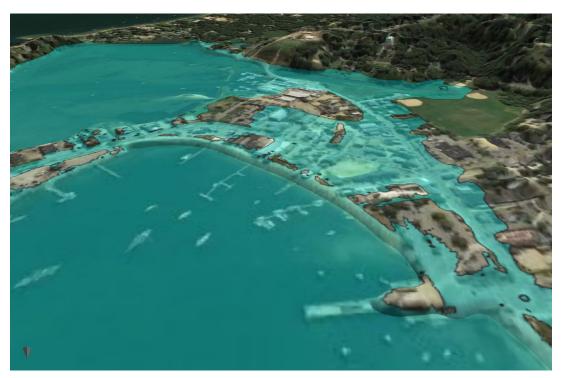
Figure 3 Flooding extents downtown during a 4.5-foot NAVD storm water level if no resiliency measures are incorporated in to Vineyard Haven.

In order to protect downtown infrastructure to a specific elevation, it is important that all flood pathways below the target elevation (5.0 feet NAVD) are mitigated. The importance of including all designs is shown in the comparison of an example 4.5 ft NAVD flood elevation for the existing conditions (Figure 3) and a scenario in which all designs are included (Figure 4).

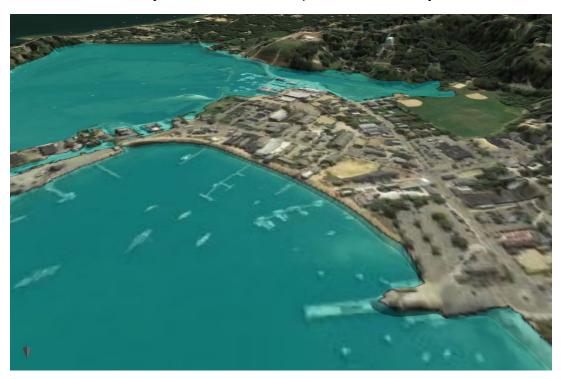
Figure 4 Flooding extents downtown during a 4.5 foot NAVD storm water level if all resiliency designs are accounted for.
