VETERANS MEMORIAL PARK MASTER PLAN

Open Space and Recreation Committee

Tisbury, MA July 2024

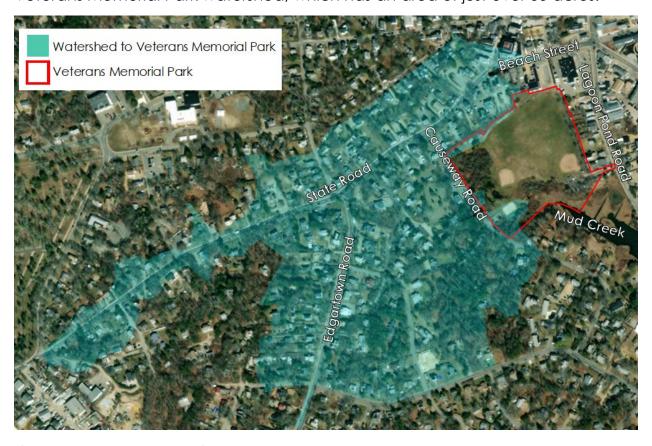
Figure 2 The Veterans Memorial Park Watershed

Town and state mapping information, previous studies, and other information on the physical conditions of the park was compiled and reviewed. On November 3, 2022 HW staff visited the Park and surrounding contributing watershed to the Park's stream draining to Muddy Pond to conduct an initial assessment for potential opportunities for stormwater management. During the site visit HW staff observed conditions within the Park, logged existing drainage infrastructure throughout the watershed, confirmed the extent of the watershed boundary, identified and geolocated preliminary stormwater control measure (SCM) opportunities, and observed constraints for those opportunities. Tisbury OSRC members accompanied the HW team for a portion of the day. The Veterans Memorial Park watershed – the land area that contributes runoff to the park – was delineated using a combination of existing GIS-based topography, stormwater drainage system maps, and field observations. Figure 2 depicts the Veterans Memorial Park watershed, which has an area of just over 55 acres.

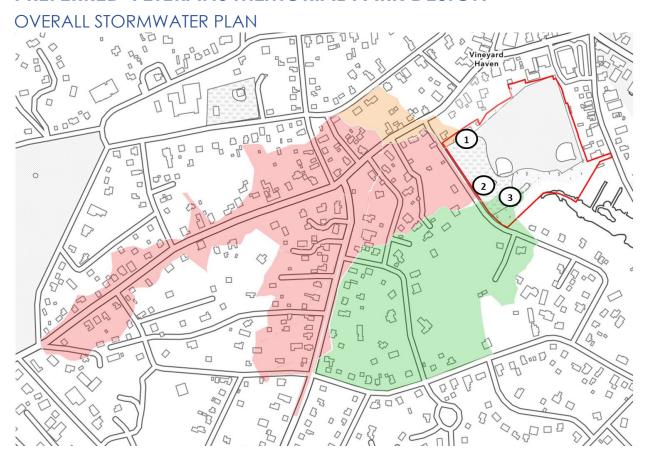
Figure 3 Drainage Areas to Stormwater Control Measures

Stormwater Control	Total Drainage	Impervious Area	Percent
Measure Name	Area to SCM	in Drainage Area	Impervious in
and location			Drainage Area
1) Causeway Road	2.7 acres	1.17 acres	43%
1			
2) Causeway Road	31.2 acres	12.6 acres	40%
2			
3) Causeway Road	21.28 acres	4.27 acres	20%
3

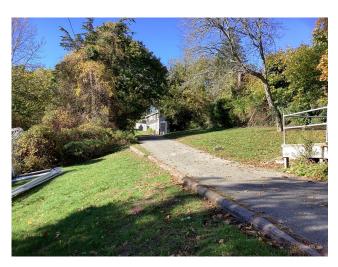
(1) Causeway Road 1

Contributing drainage area: 2.70 acres
